# What's That Smell, And Why Does My Head Hurt?

Story and Photo  
By Mark Wilkins,  
PWC Norfolk, Va.

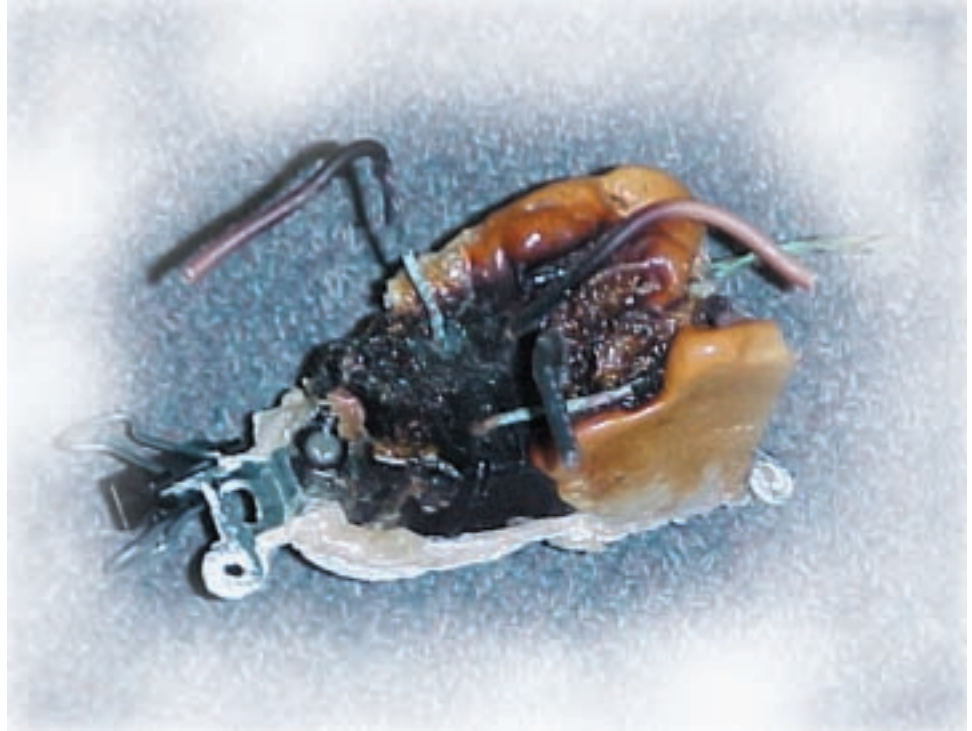
This “bug” is what was left after someone sprayed expanding-foam insulation into an electrical-receptacle box.

After quickly disconnecting the power, John removed the faceplate, only to find a black molten mess. More than half the spray insulation had melted away from the wires. He had found the source of the odor, as well as the headaches. He called an electrician to make the necessary repairs and to insulate the space. The electrician said the house was close to catching on fire.

What lesson did John learn from this incident? Always read and follow the manufacturer's instructions when using any product. He had sprayed the expanding foam into the electrical-receptacle box, instead of around it, as specified by the manufacturer. What appears to be a quick and easy repair may not be the most intelligent or best fix.
